LAKE CLASSIFICATION SHORT REPORT FOR ARKDALE LAKE, ADAMS COUNTY

Presented by Reesa Evans, Lake Specialist **Adams County Land & Water Conservation Department** P.O. Box 287, Friendship, WI 53934 SEPTEMBER 2007

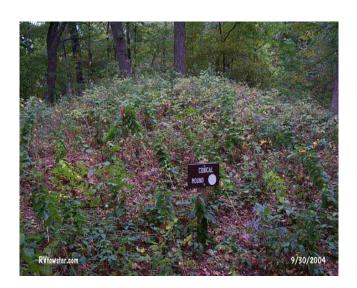
Arkdale Archeological Sites

There are many Native American archeological sites in Adams County, with Arkdale several in the watersheds, as shown on the map above. In order to preserve Native American heritage, federal and state laws prohibit further disturbance of these sites without permission of the government and input from the local tribes.

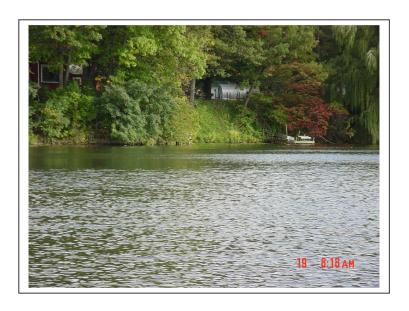
Example of Adequate Buffer

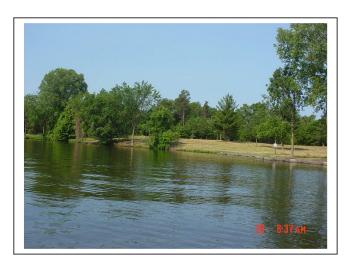
Most of the "inadequate" buffer areas were those with traditional mowed lawns, rock riprap and insufficient native vegetation at the shoreline to cover 35 feet landward from the water line. Heavy erosion was noticed on the island shorelines at the east end of the lake.

Example of Inadequate Buffer

• Lake residents should protect and restore natural shoreline around Arkdale Lake. The lower frequency and density of the most sensitive plant species in the disturbed shoreline areas is evidence that shore disturbance is impacting the aquatic plant community of the lake.
